**Production and Interpretation of Aerial Photographs for the Following Fifteen Sites:**

**Aero-Data Corporation LLC**

**January 12, 2018**

## **MIDDLETOWN, CONNECTICUT**

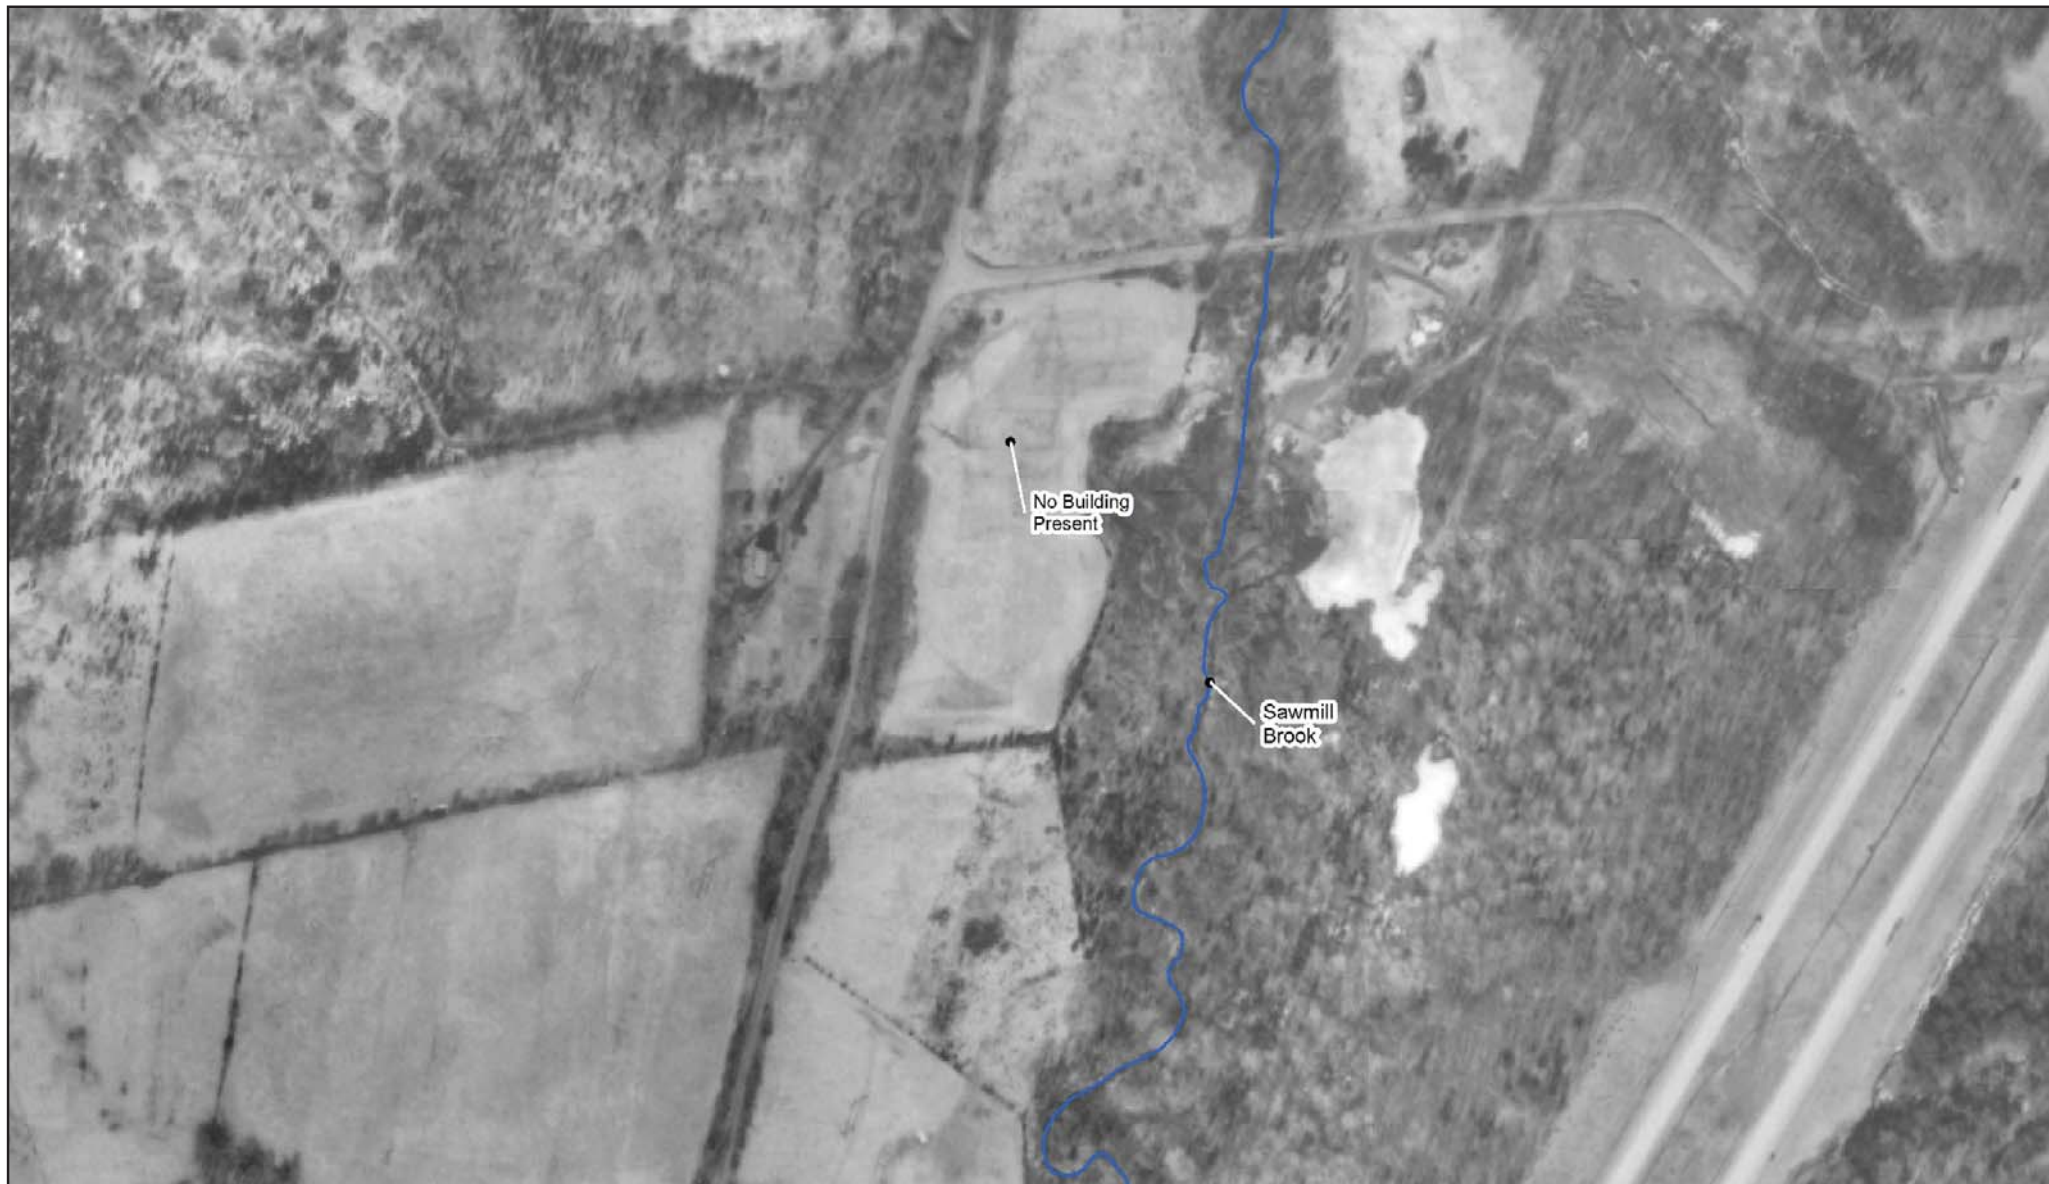
**3/9/1970**  
**Middletown, CT**  
Photo Source: UCONN

The facility is not yet visible. Vegetated fields are visible on the Site. By the next date of photography, 6/28/1970, construction activities will be visible on the Site.

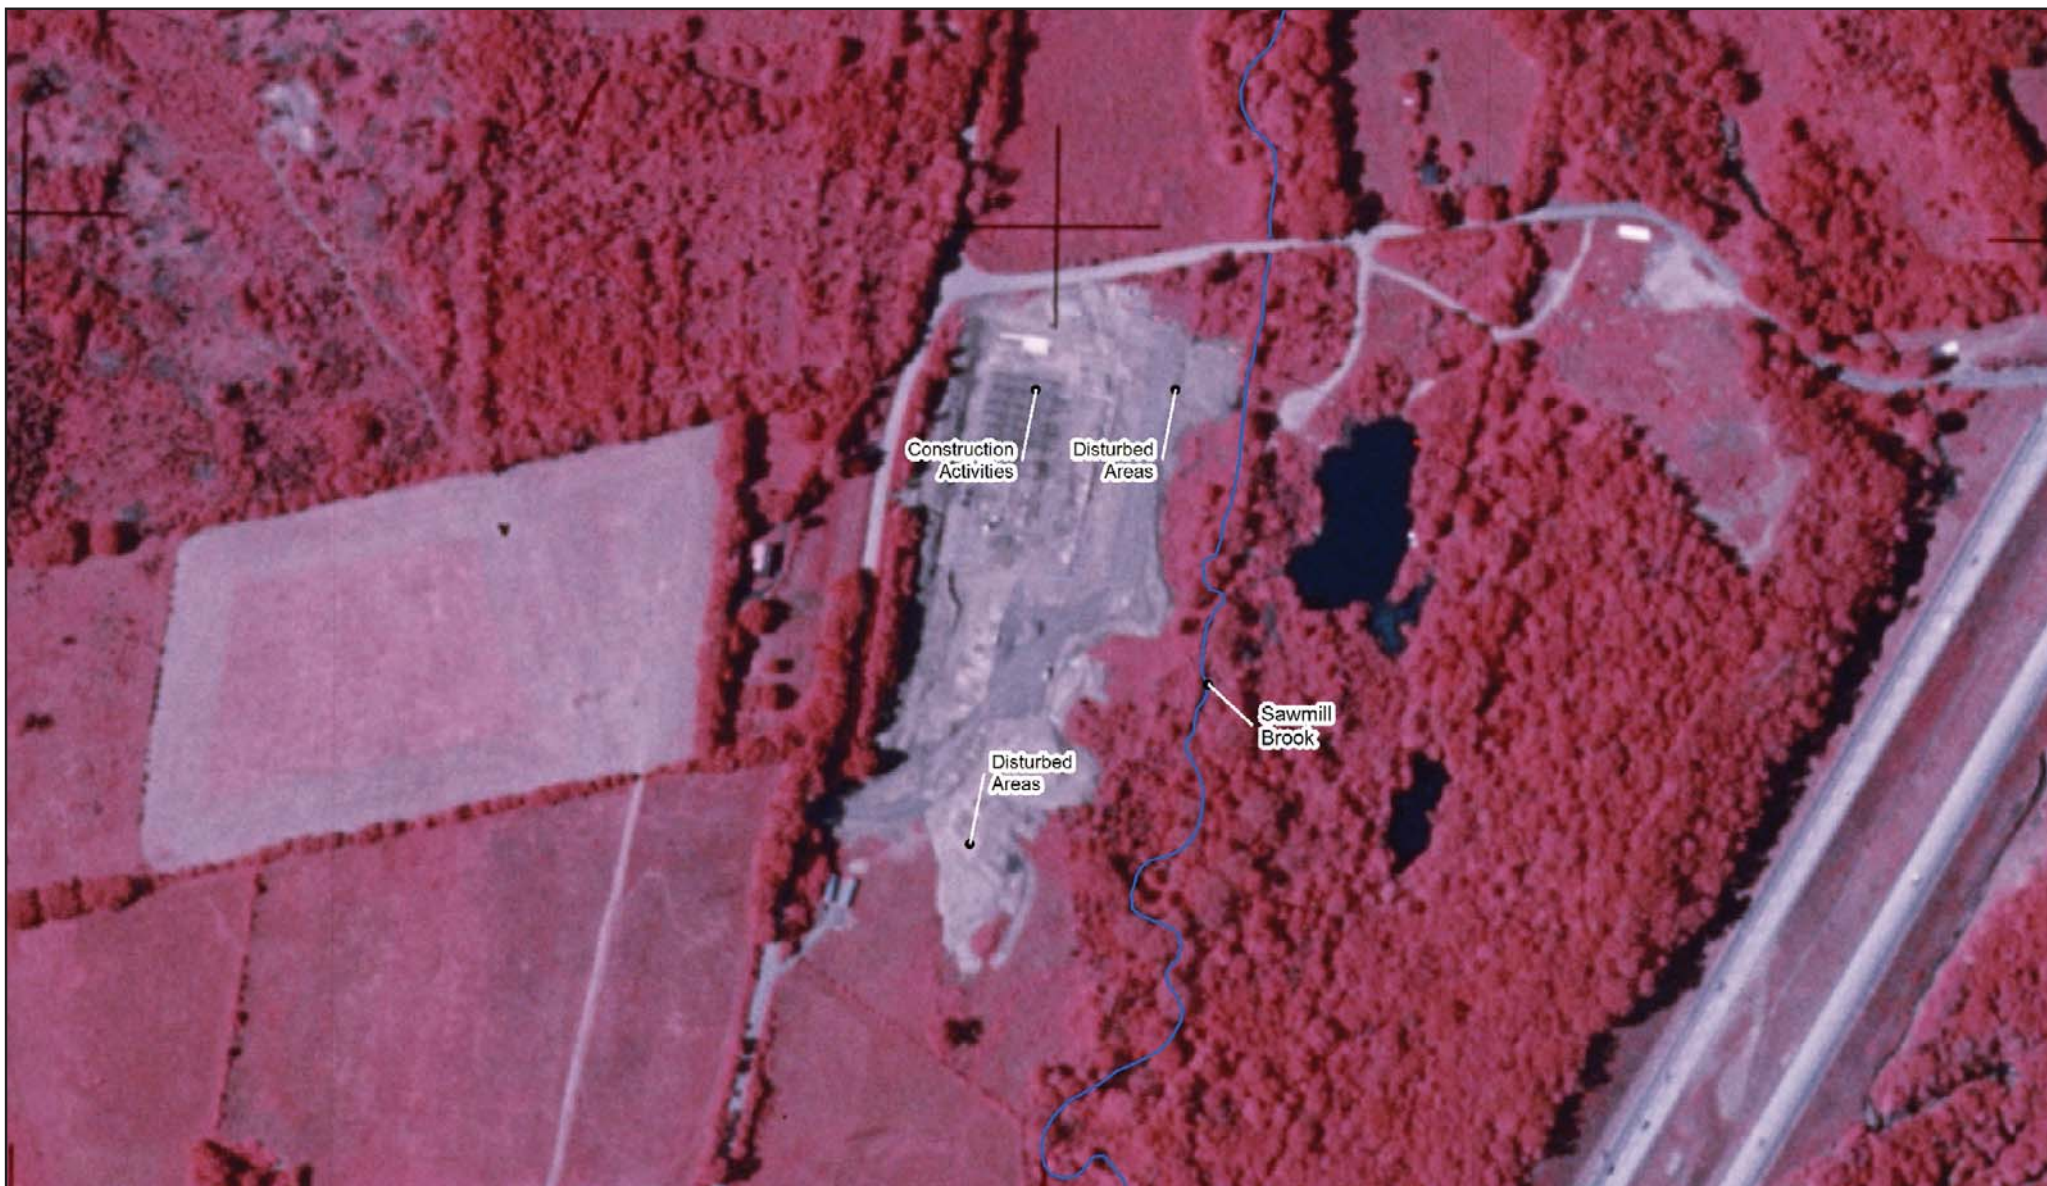
**6/28/1970**  
**Middletown, CT**  
Photo Source: USGS

Construction activities including disturbed areas/earthmoving are visible.

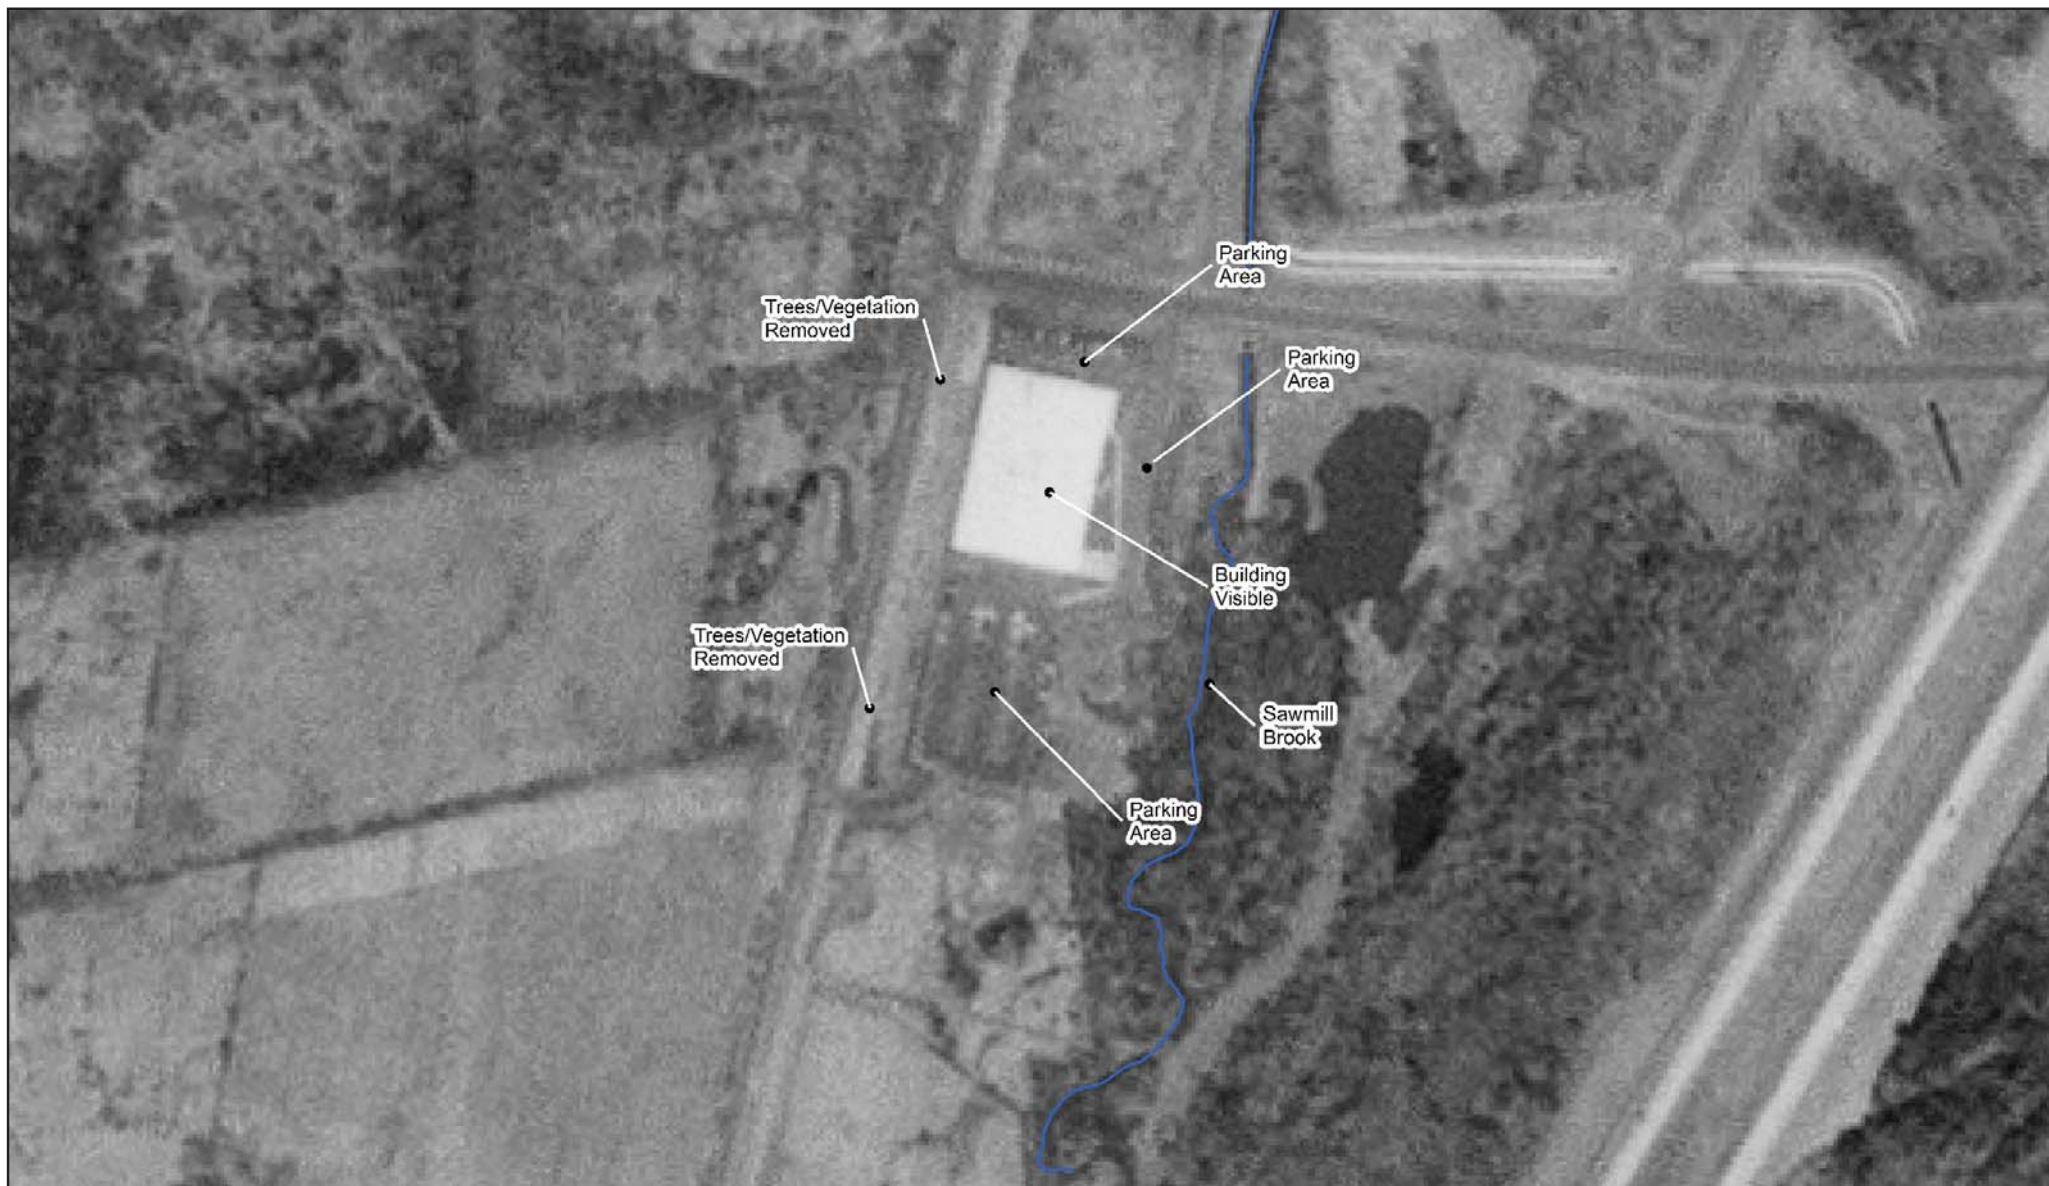
**4/26/1972**  
**Middletown, CT**  
Photo Source: USGS

A building is visible with parking areas to the north, east and south. Vegetation/trees have been removed between the building and Middle Street.

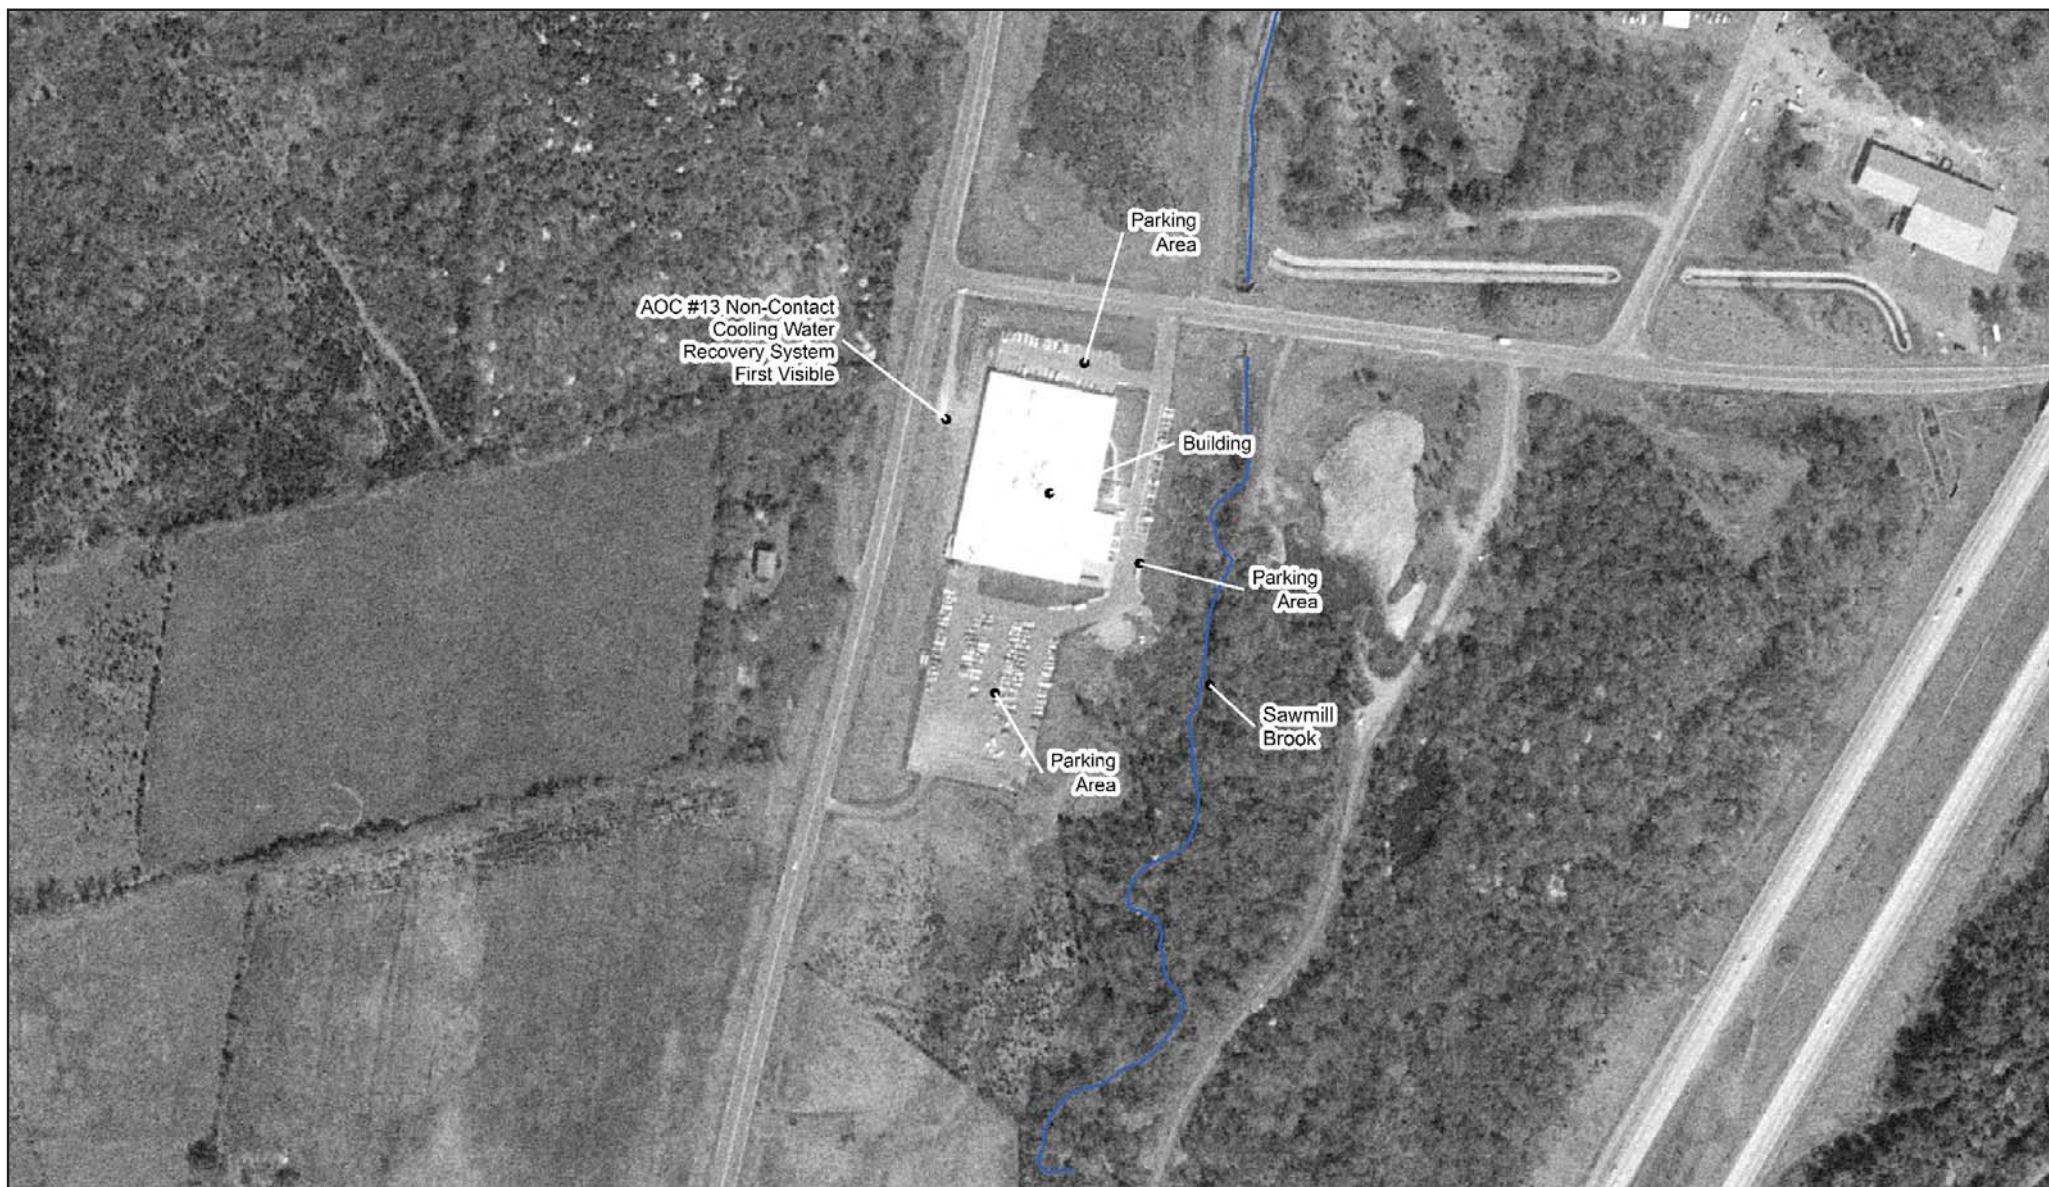
**5/4/1976**  
**Middletown, CT**  
Photo Source: USDA

The building remains visible with parking areas to the north, east and south. The Non-Contact Cooling Water Recovery System (AOC #13) is first visible to the northwest of the building near the intersection of Smith Street and Middle Street.

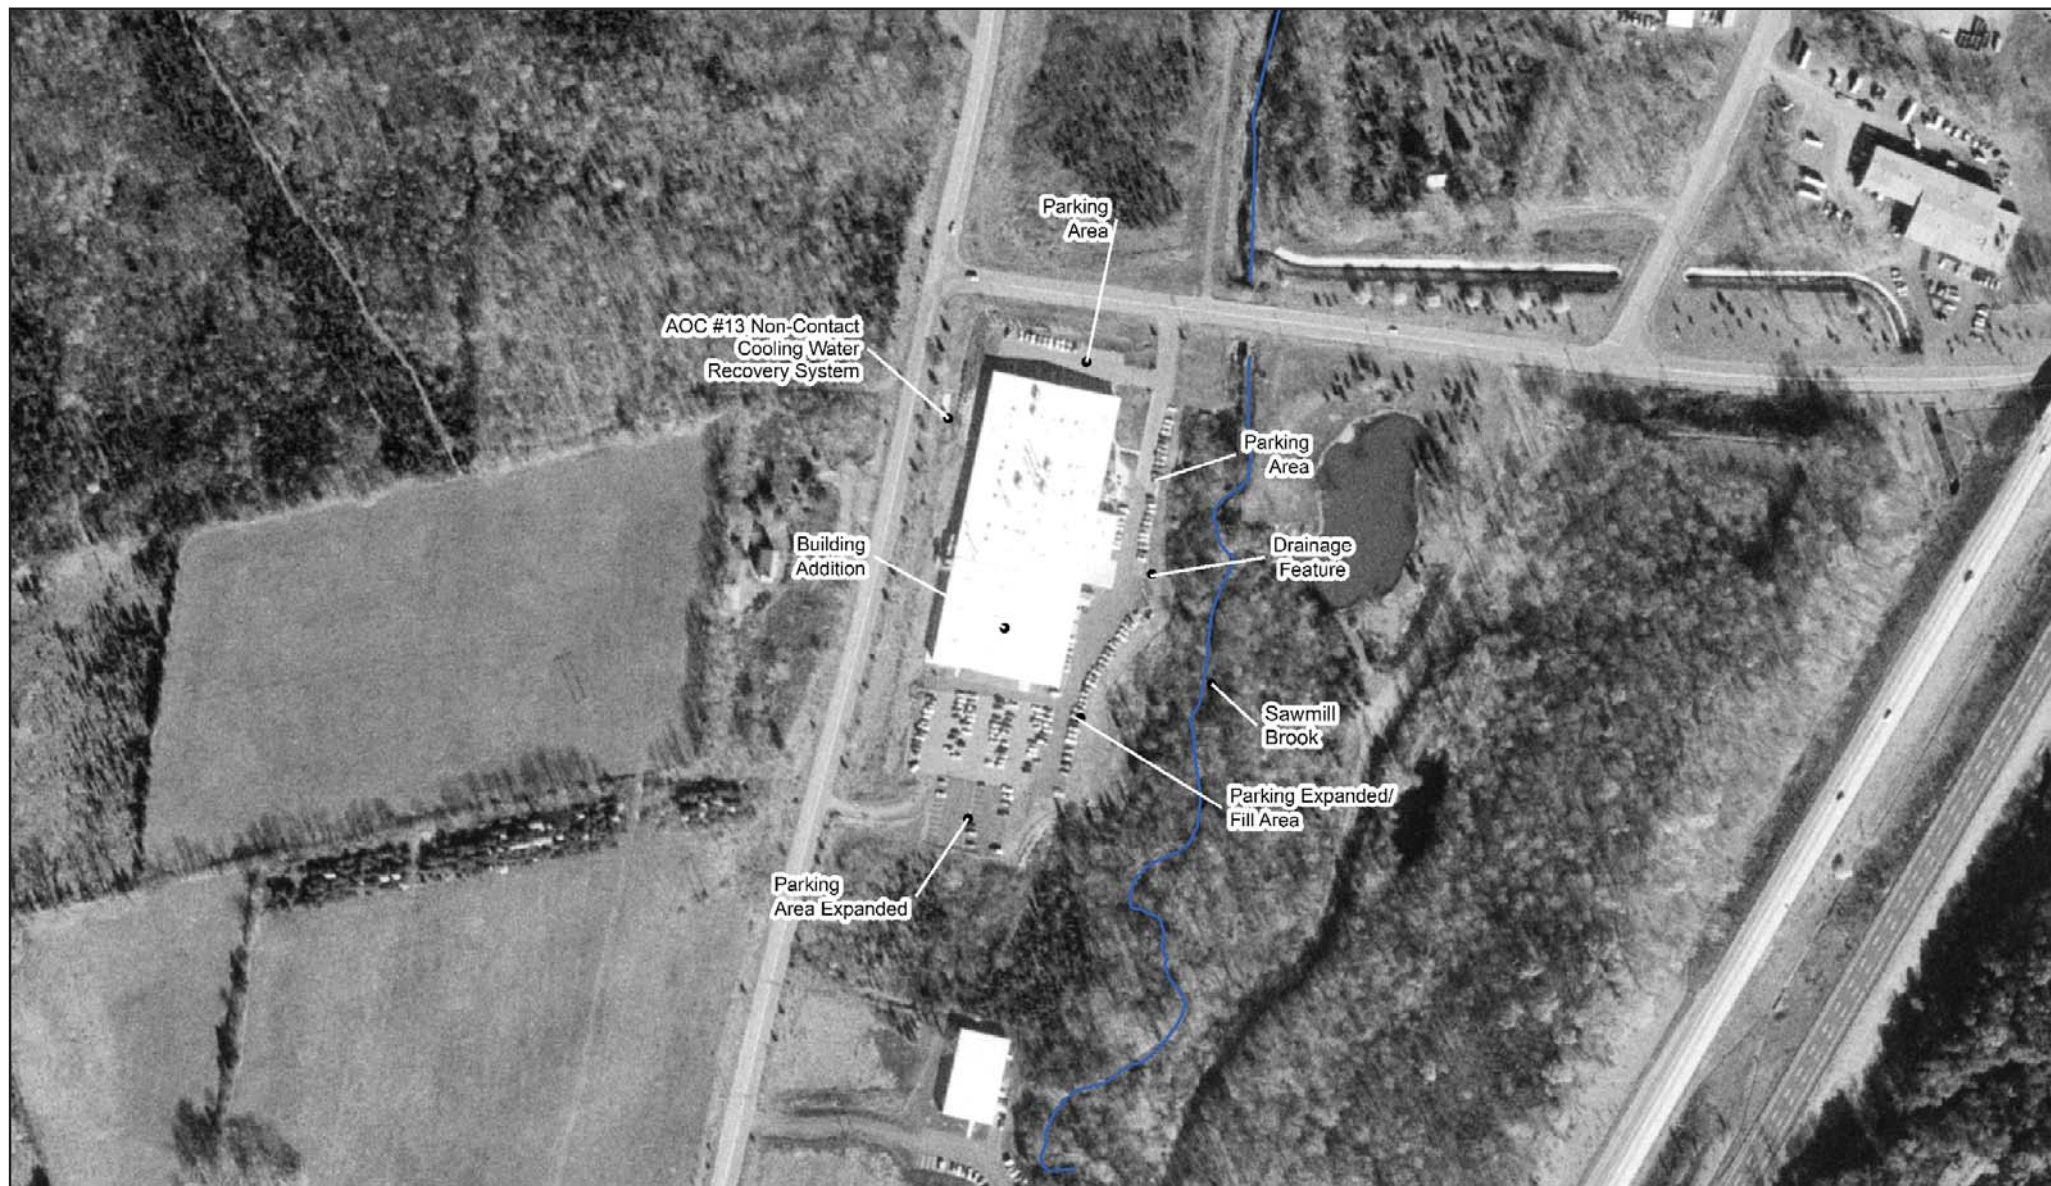
11/3/1981  
Middletown, CT  
Photo Source: USDA

A building addition is visible for the first time south of the existing building. New fill material and expanded parking areas are visible southeast of the building. An additional new parking area is visible south of the building. A drainage feature is visible east of the building and drains towards Sawmill Brook. The Non-Contact Cooling Water Recovery System (AOC #13) remains visible.

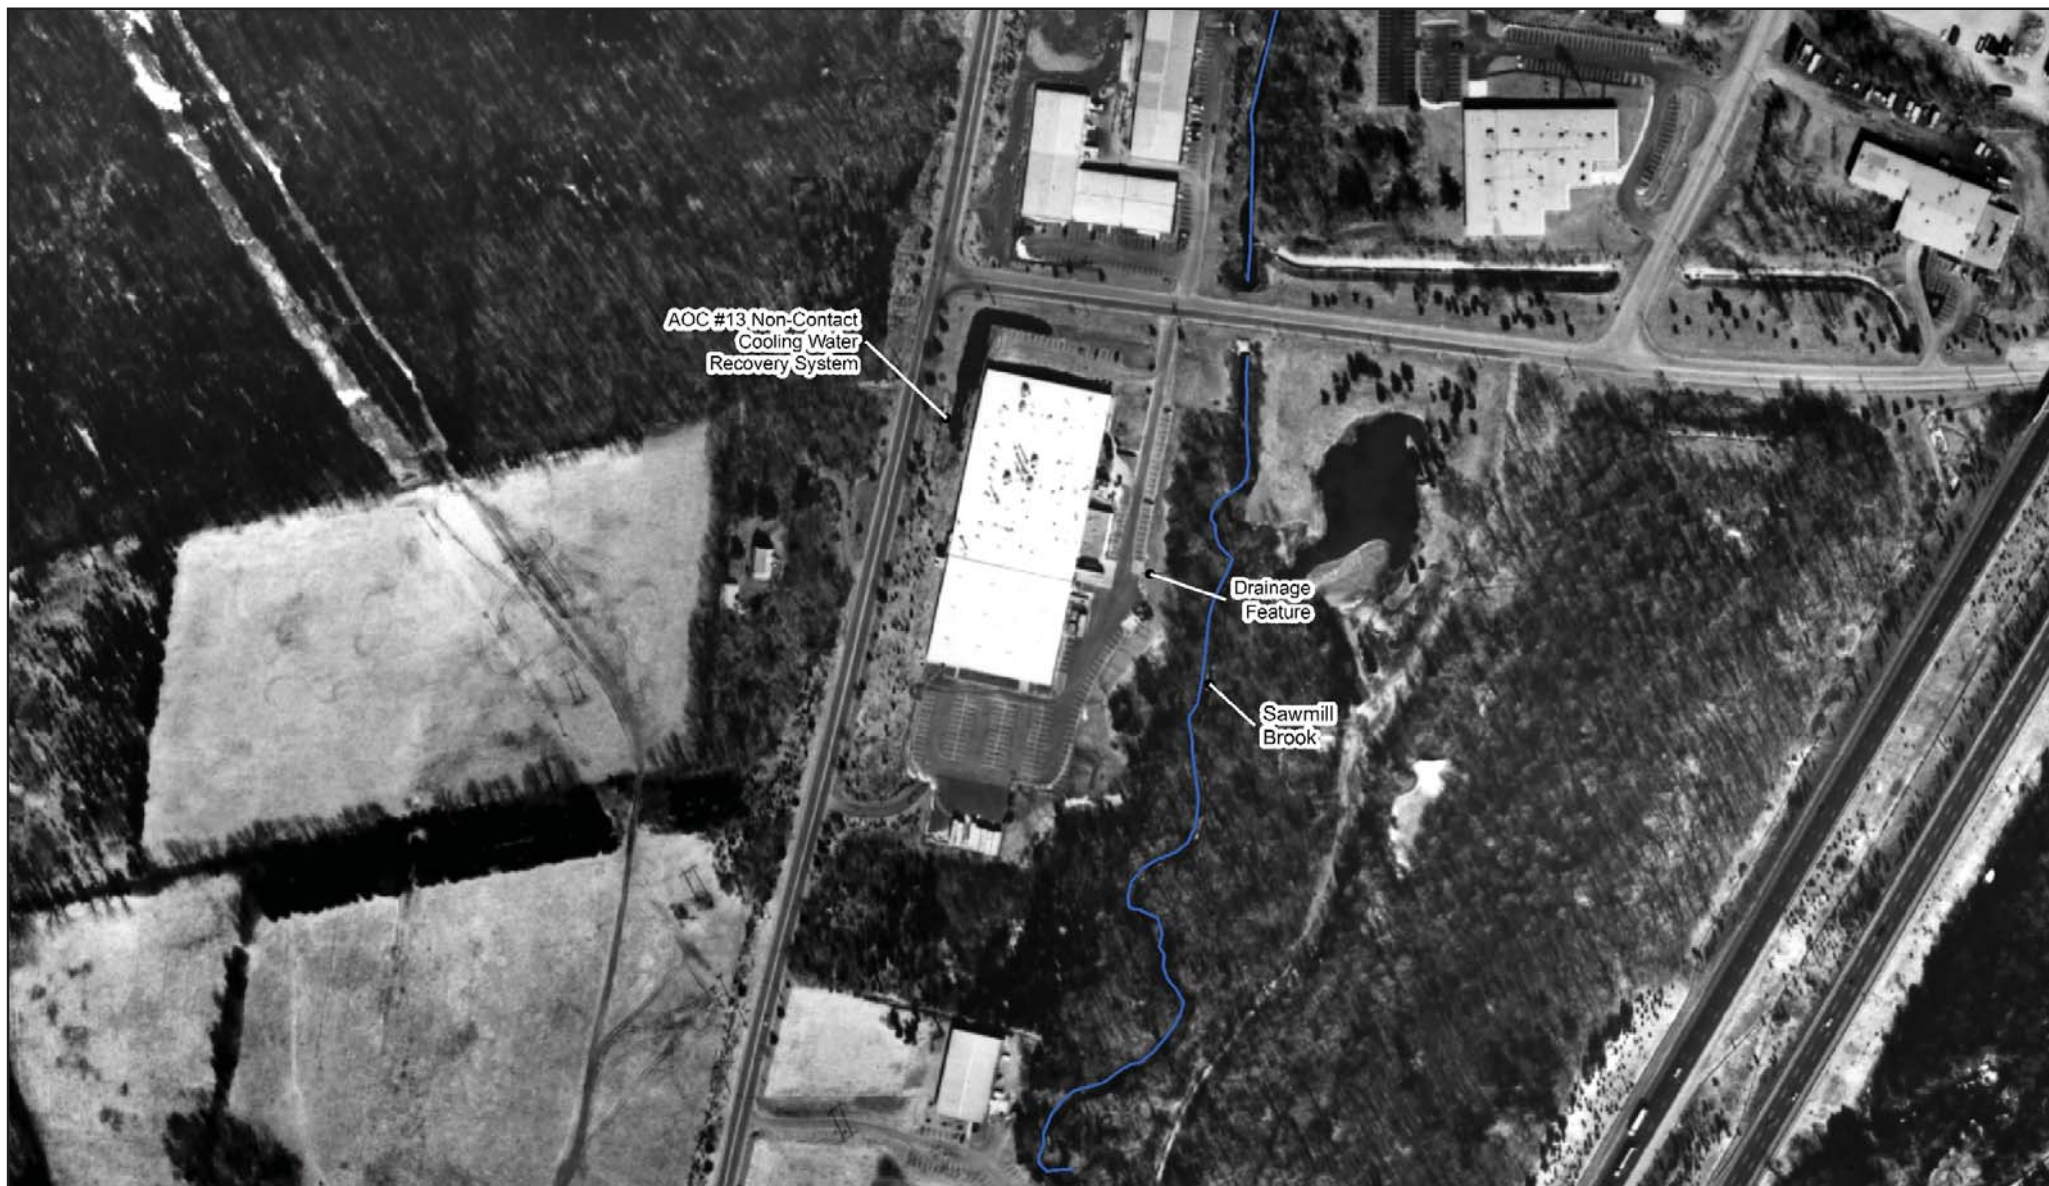
3/8/1986  
Middletown, CT  
Photo Source: UCONN

The drainage feature remains visible east of the building and drains towards Sawmill Brook. Few cars are visible in the parking lots. This photograph was taken on a Saturday. The Non-Contact Cooling Water Recovery System (AOC #13) remains visible.

AOC #13 Non-Contact  
Cooling Water  
Recovery System

Drainage  
Feature

Sawmill  
Brook

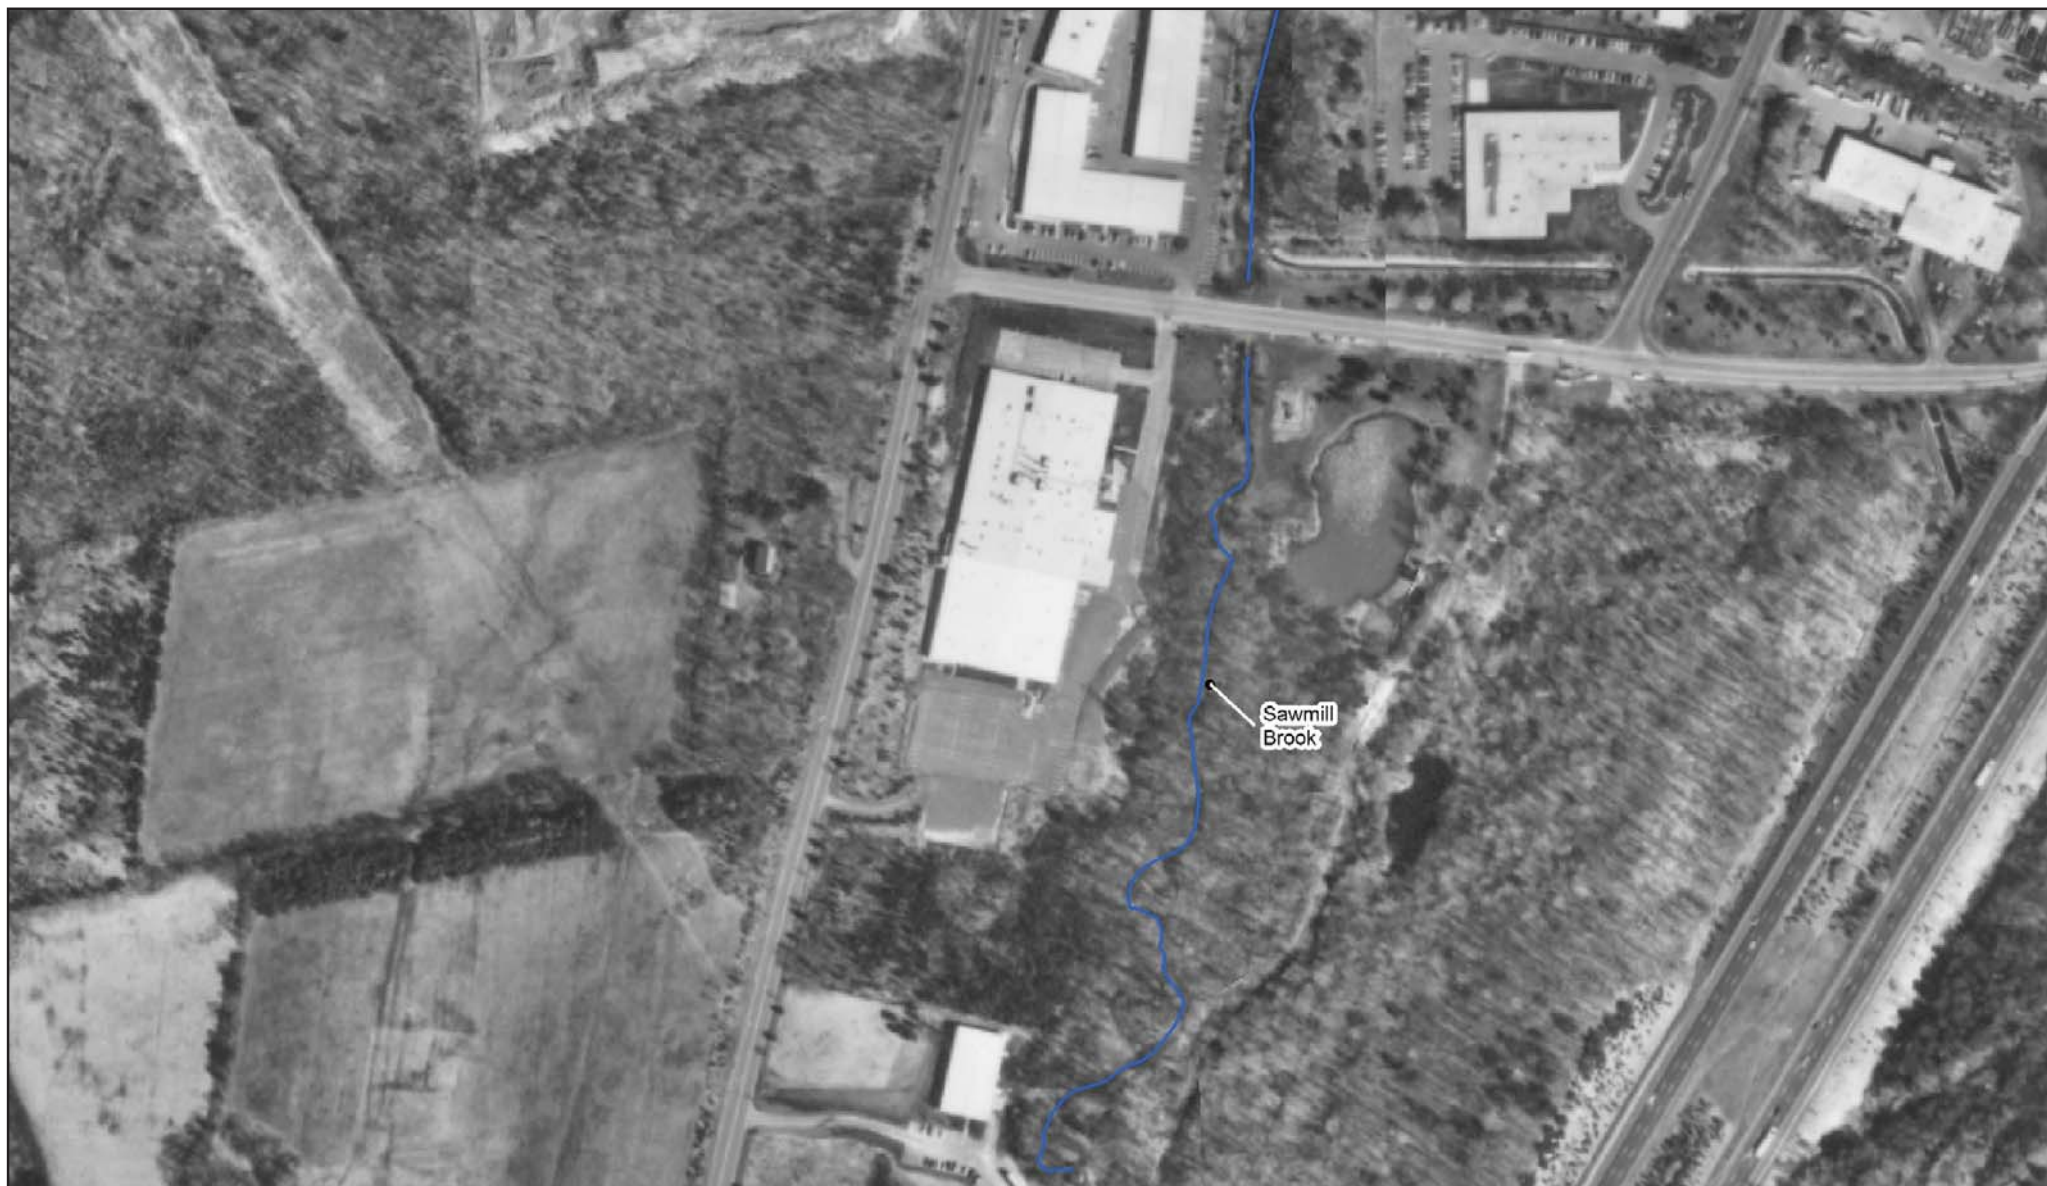
4/19/1990

Few cars are visible in the parking lots. This photograph was taken on a Thursday.

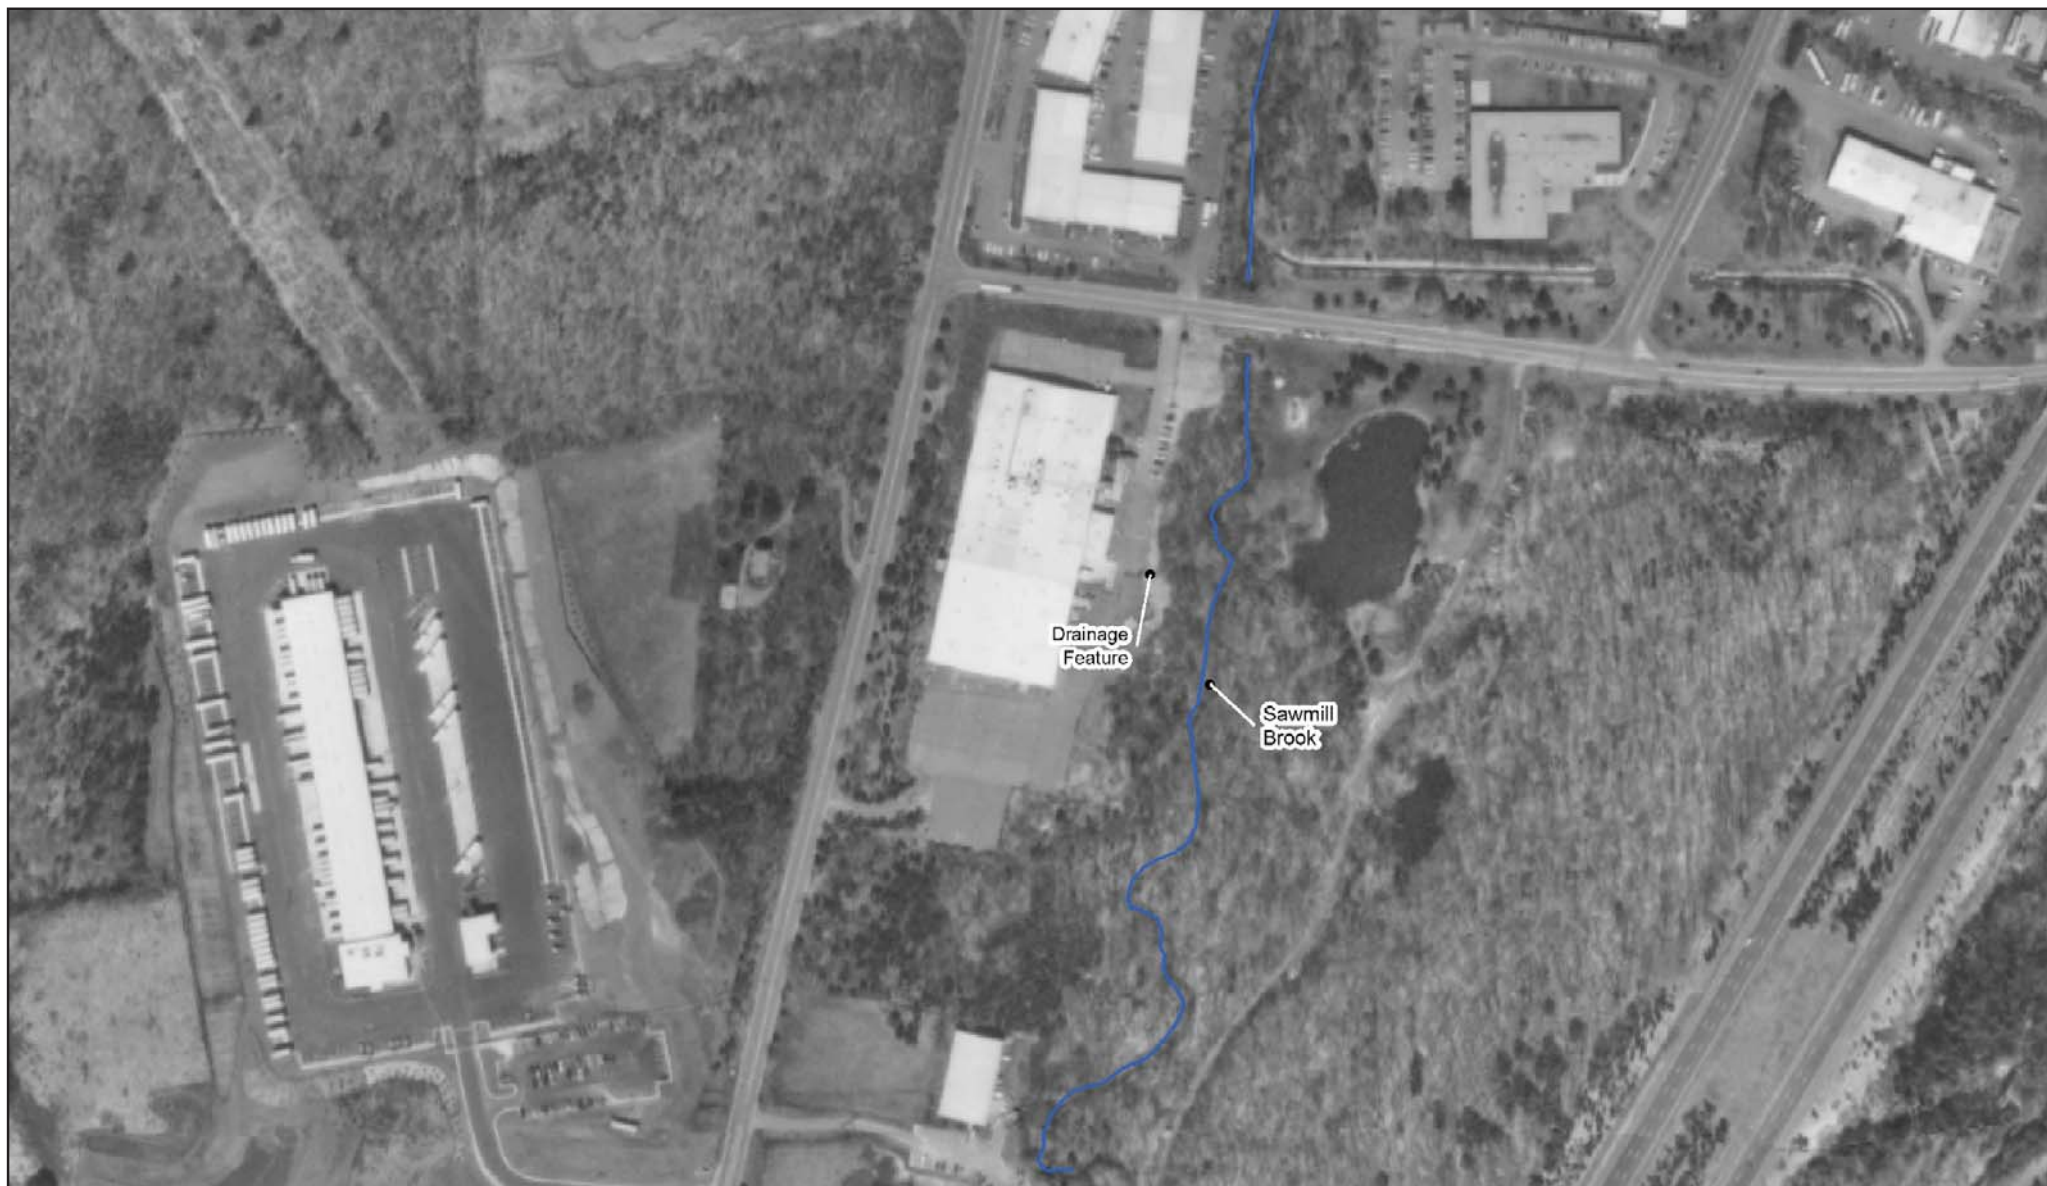
4/20/1995  
Middletown, CT  
Photo Source: UCONN

The drainage feature is visible east of the building and drains towards Sawmill Brook. Few cars are visible in the parking lots. This photograph was taken on a Thursday.

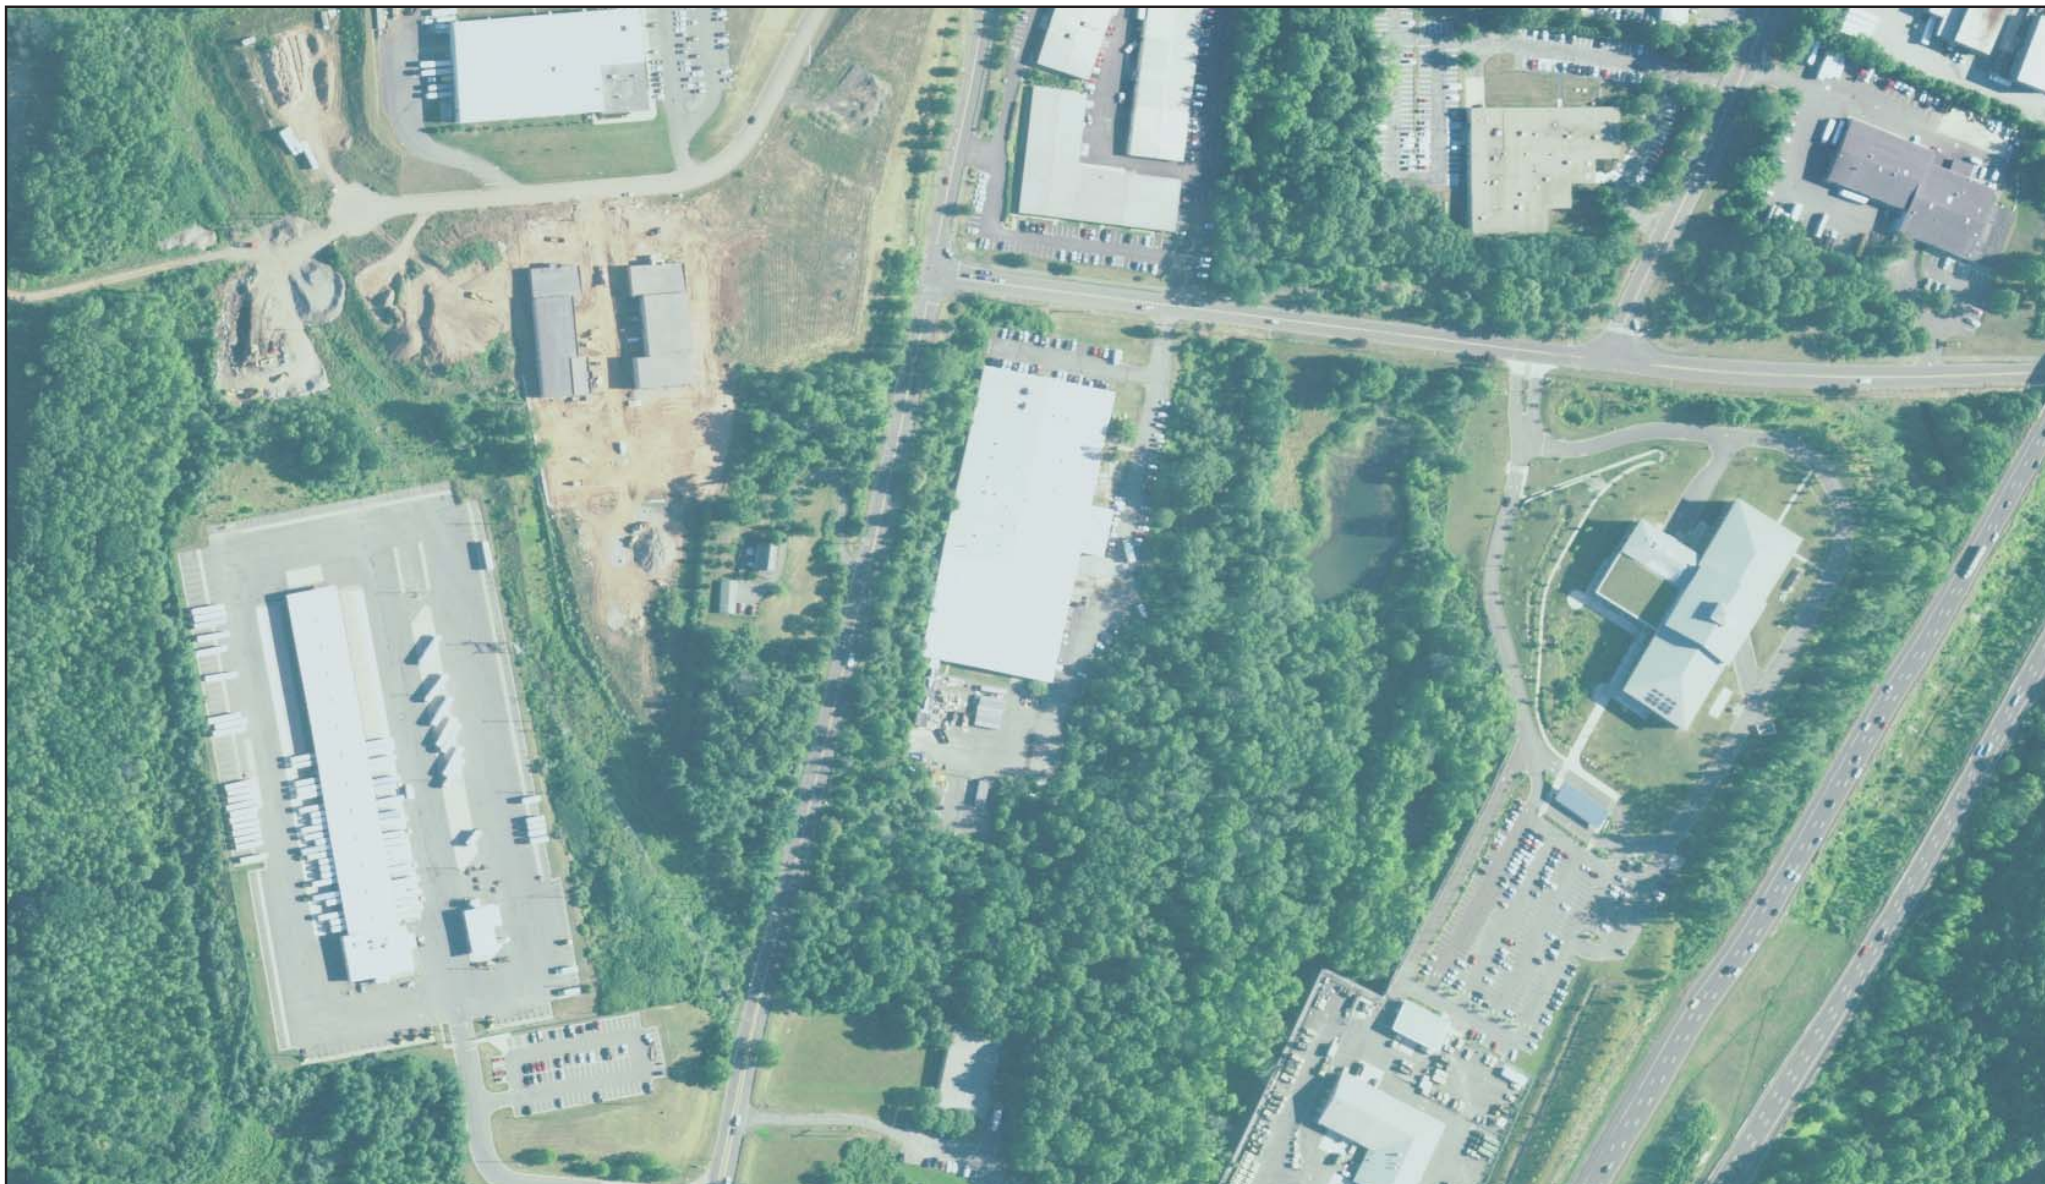
**7/27/2016**  
**Middletown, CT**  
Photo Source: USDA\_NAIP

The building remains visible with cars present in the parking lot.
